Uni Epson IV OEM Chip Reset Operation Instruction V1.0

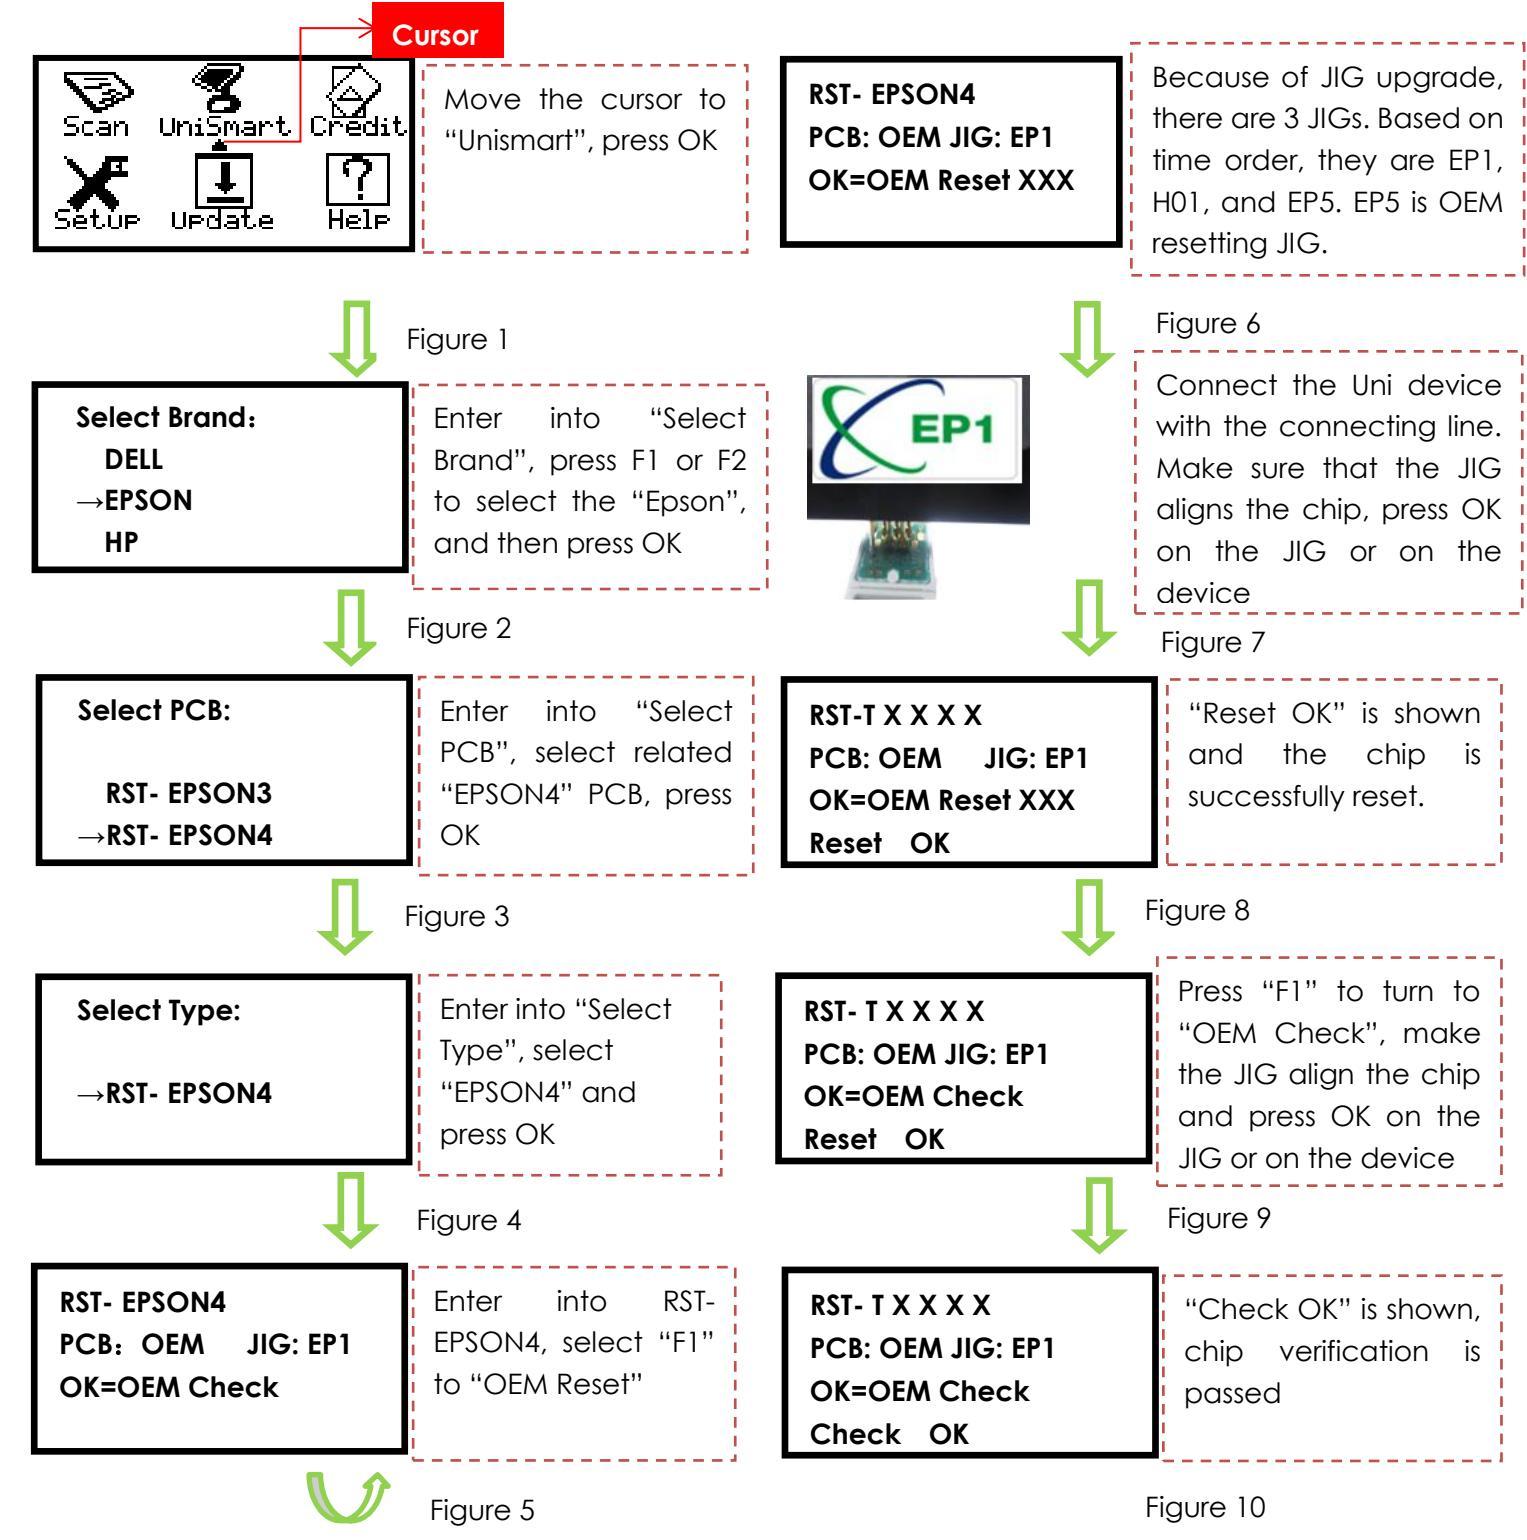
OEM Reset and OEM Check

Note: the operation procedure above is for EPSON-4 series and it can also be applied to other PCB boards.
